Manhole Inspection Summary

Manhole # S13A1_009MH

Insp Date: **3/27/08 10:04 AM**

Location Address: **1301 Forrest Ave**

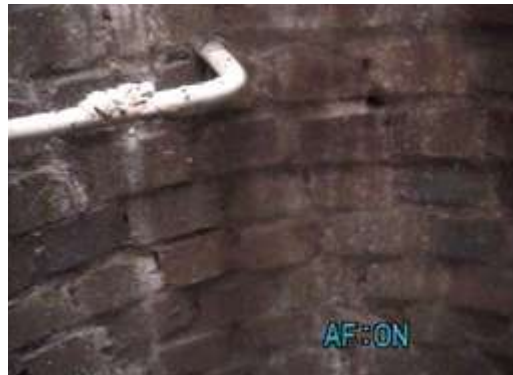
Defect 2

Infiltration: ☐ None ☒ **Joint** ☐ Cracks ☐ Mortar ☐ Roots ☐ Wall

chimney infiltration

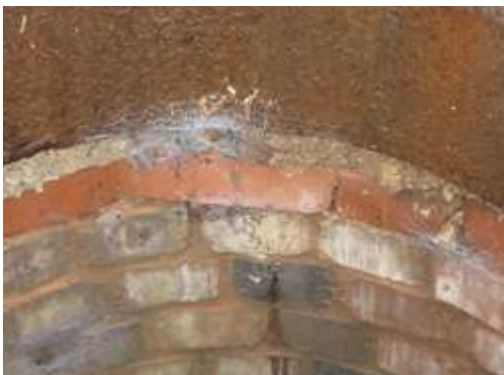
Defect 1

☒ **Leaks**

lid-frame infiltration

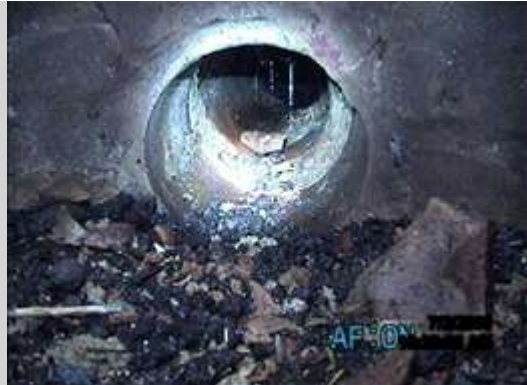
12 O'Clock Outflow

8 in. Circular Gravity Sewer
Pipe Out @ 12 O'Clock

Infiltration: **Evidence** Pipe Seal Cond: **Unknown**
